Phase 3 – 2021 : Experiments with Sod Built Iron Smelting Furnaces, based on Hals, Iceland

ABSTRACT :

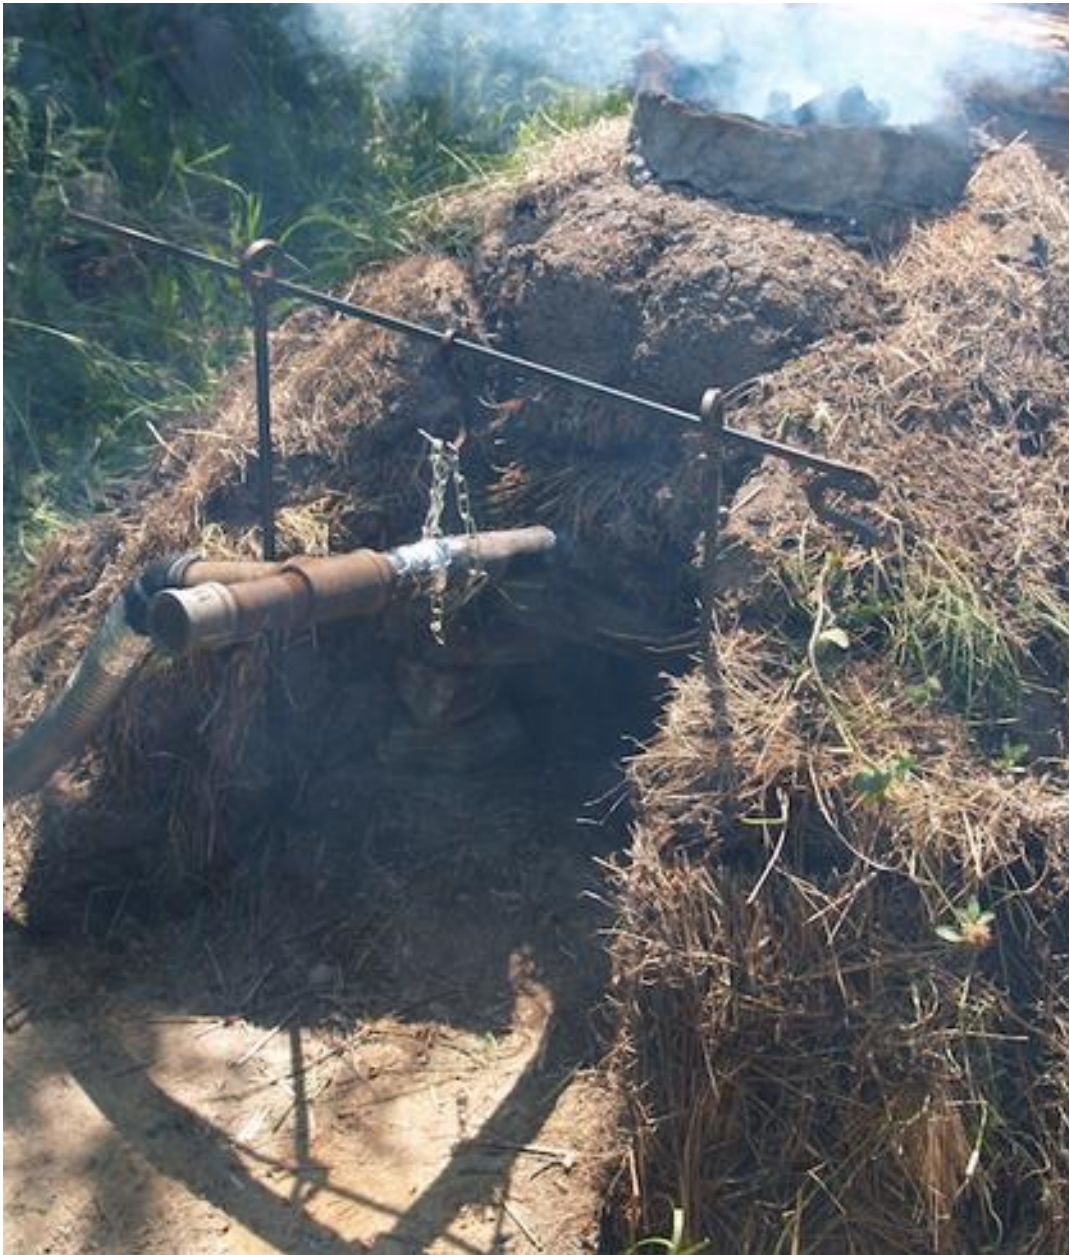
Furnace with air system in place, at first addition of charcoal.

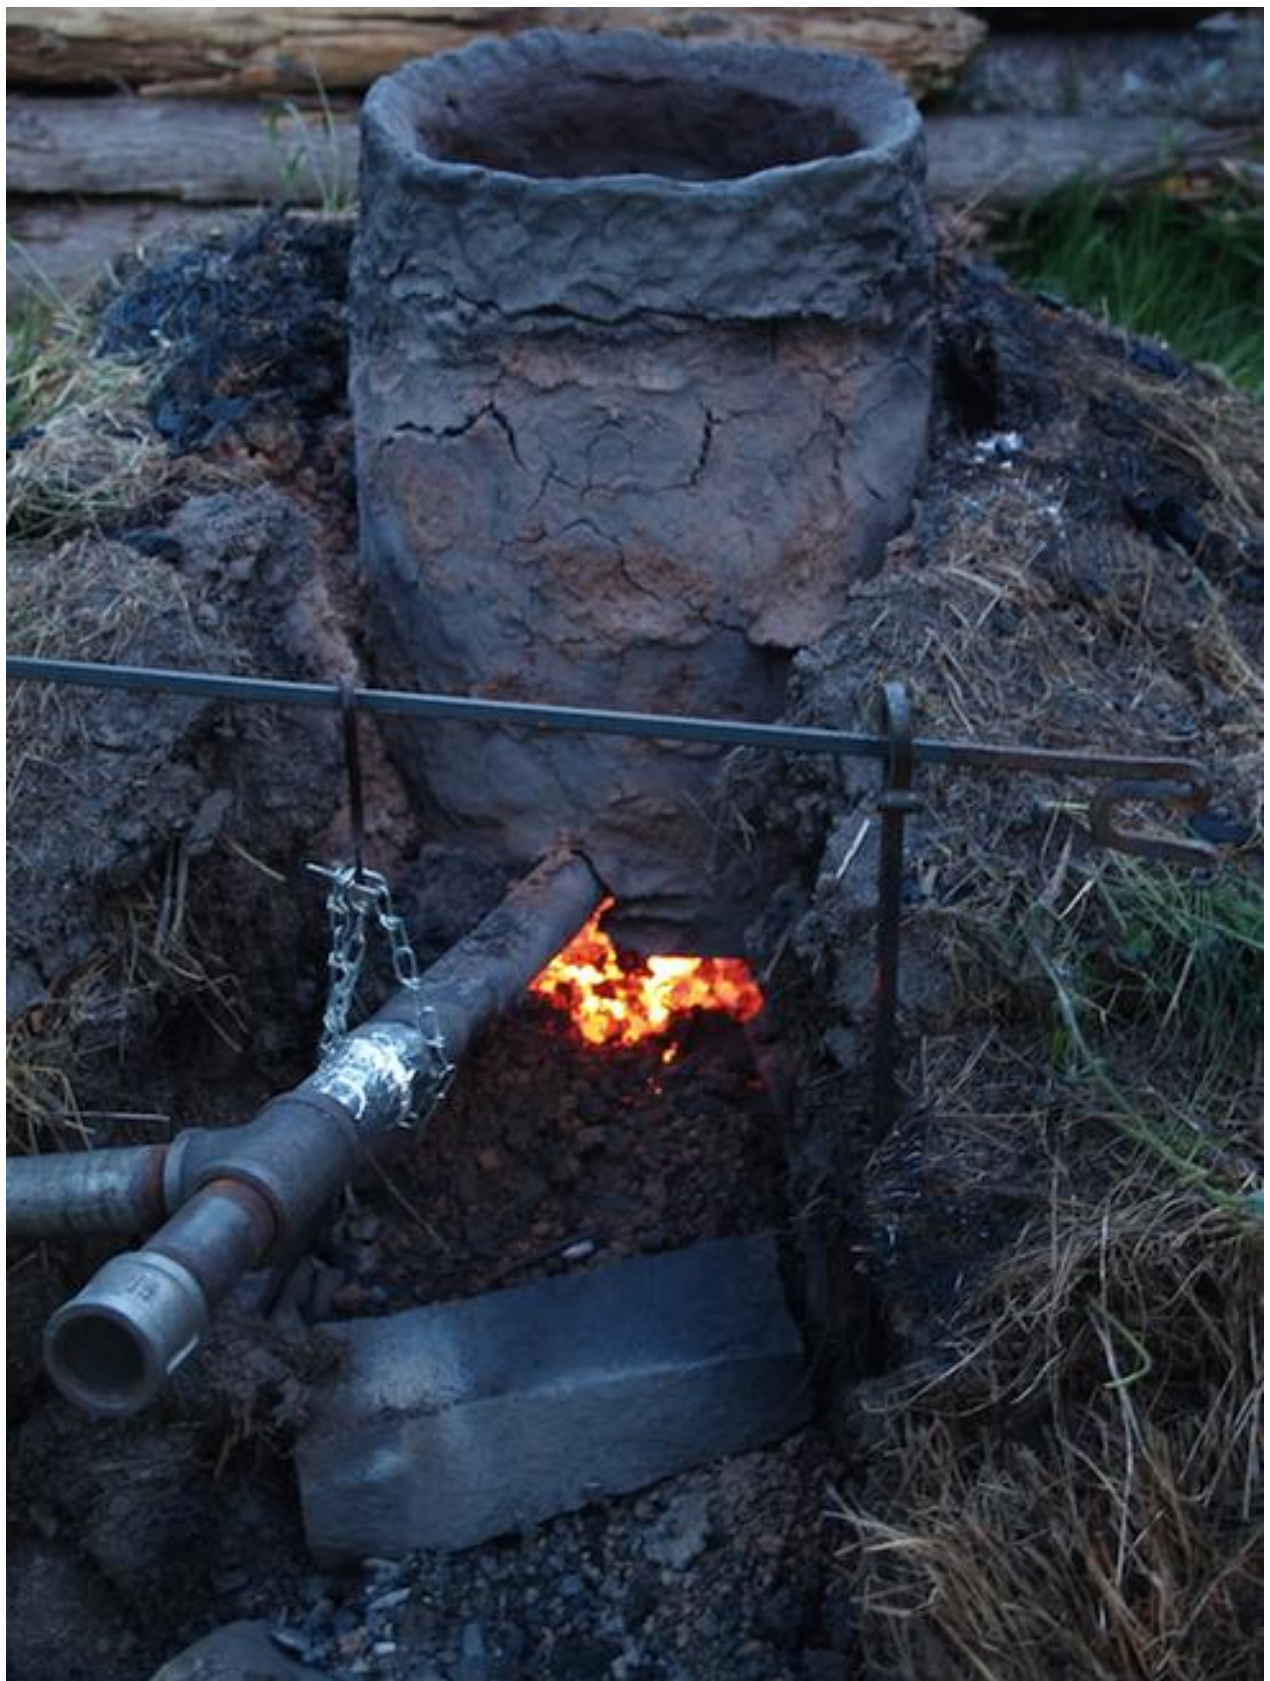
Furnace just after extraction – June experiment.

Inside the furnace itself, there was considerable erosion of the clay liner, following the expected oval pattern centred around the tuyere. At some places (especially close to and above the tuyere) the wall thickness had been reduced from the starting 4.5 cm to as little as an estimated 1 cm thick, all now heavily slag coated. The Icelandic clay mix did survive a full smelting cycle, but with more erosion damage than was the case with the standard EPK clay base normally used. This depth of erosion suggested that if the wall thickness had been much less than the 4.5 cm used, failure due to melting through the walls would certainly have occurred. On examining the overall damage to the furnace structure as it slowly cooled, it was felt that it would prove fairly easy to repair the lower sections that had broken away, and layer fresh clay onto the eroded areas inside.

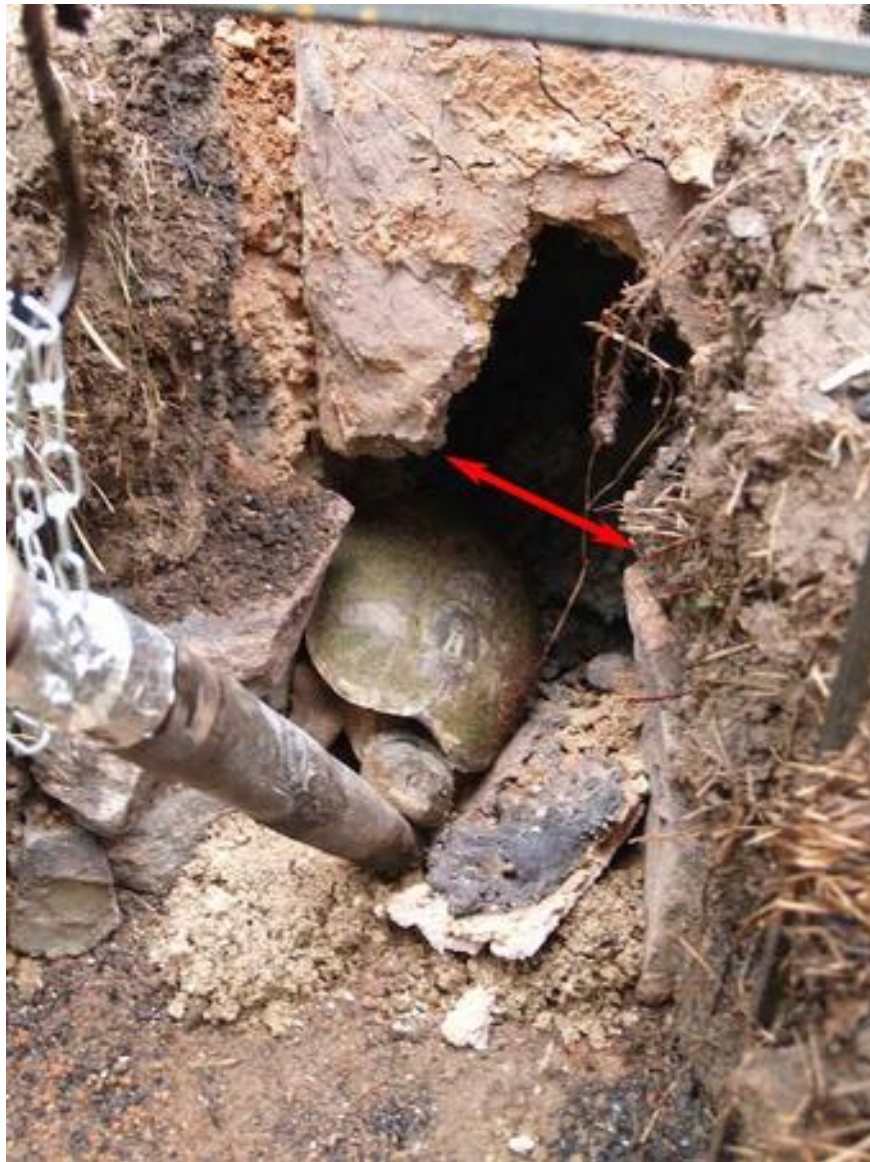
Likely in the early dawn hours, a roughly 20 cm long snapping turtle had crawled into the still warm furnace! (A) This resulted in additional damage to the front of the furnace. (In the image above the red line shows approximately the lower line of the furnace wall at the end of the smelt. The larger piece seen lying to the right of the turtle was the section broken free.)

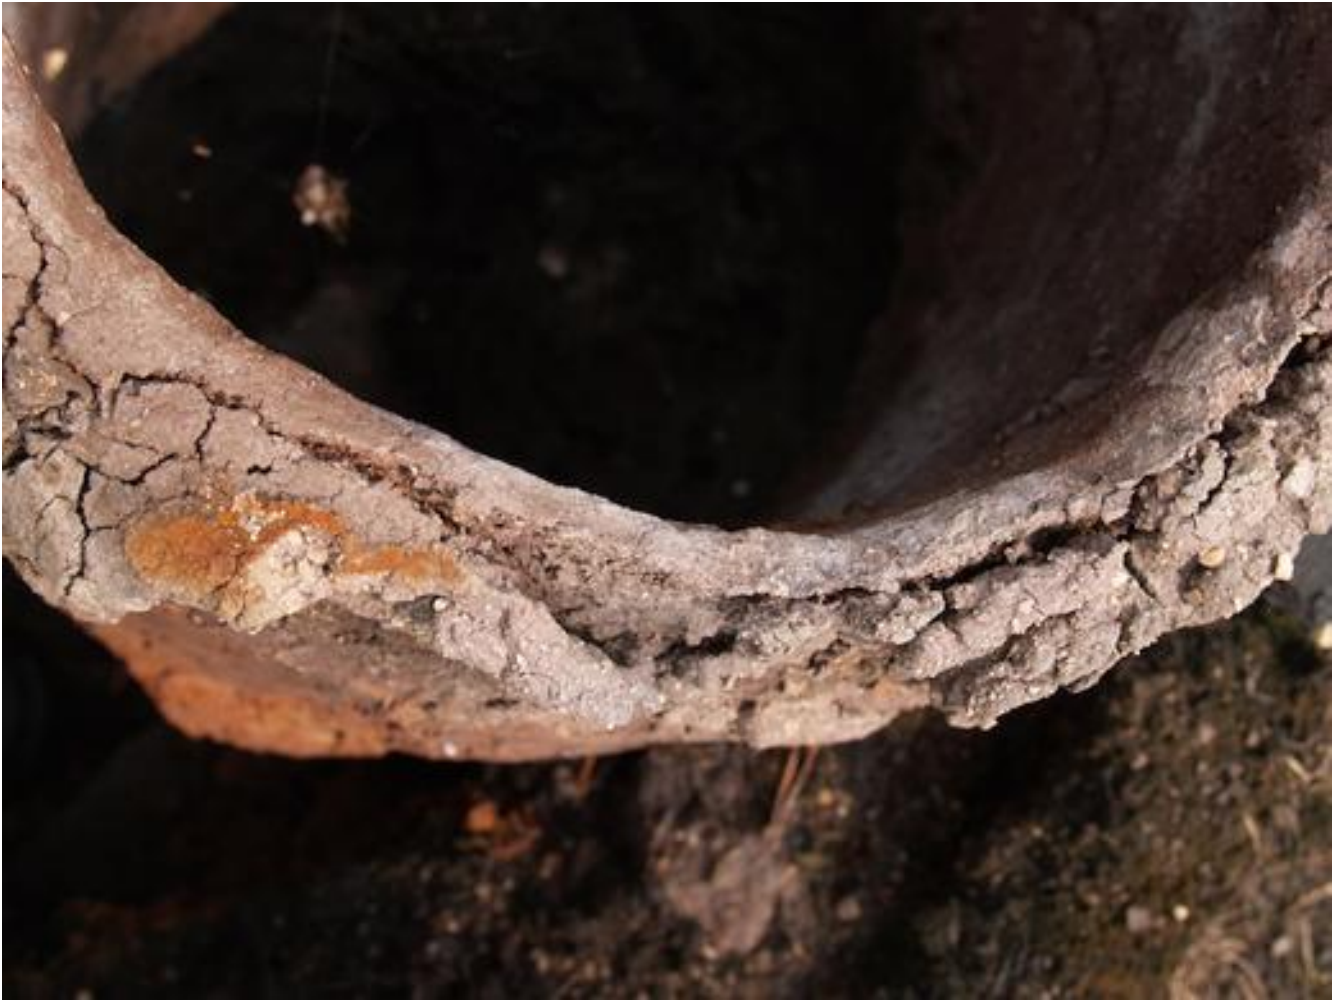
Top edge of the furnace liner, above the tuyere – condition after 5 weeks.

The temperature gradient that is produced by the firing of a smelting furnace has been seen to effect clay composition walls in varying ways, which results in variation in damage effects, as a furnace is exposed to weather over time. (6) There had been an unusual amount of rain over early Summer at Wareham (a period where normally there had been little, if any, rain in past years). The fracture line seen above (image taken July 17) marks the division between the sintered interior and the 'baked mud' exterior heat effects. By early August, the outer portions had broken free along this line. There had also been considerable slumping of the sod structure, again due to the exposure to rain. With concern that the existing furnace might suffer too much damage to be easily repaired for re-use, it was decided to move the scheduled second experiment forward to the later part of August. Repairs were undertaken the week of August 9 to 13.

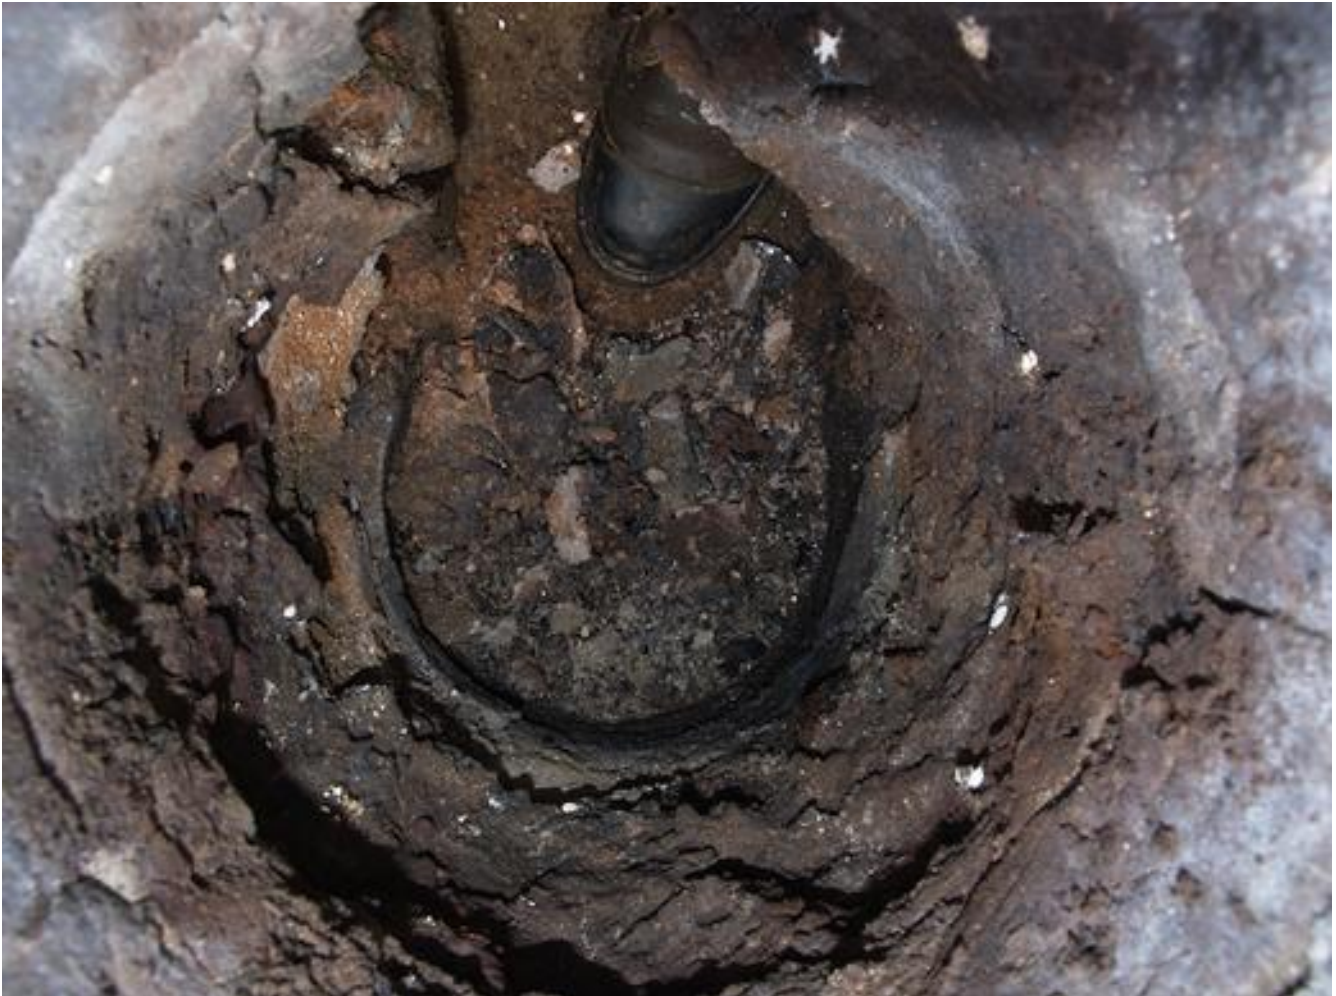
View down the interior, after slag clinging to walls and remaining lower bowl was removed. Extraction arch to the top of this image.

In the image above, the considerable heat erosion of the clay liner is clear. The smooth circular surface at the bottom indicates the starting surface, protected by the base layer of charcoal fines. The heat effects are concentrated to the central portion of the shaft, the hottest part of the interior during firing. The upper portions (although somewhat distorted here by perspective) are again seen to be relatively free from any damage. This erosion was both more extensive and considerably deeper than had been seen in previous clay walled furnaces. This was clearly the result of the significantly lower melting point of the simulated Icelandic clay body.

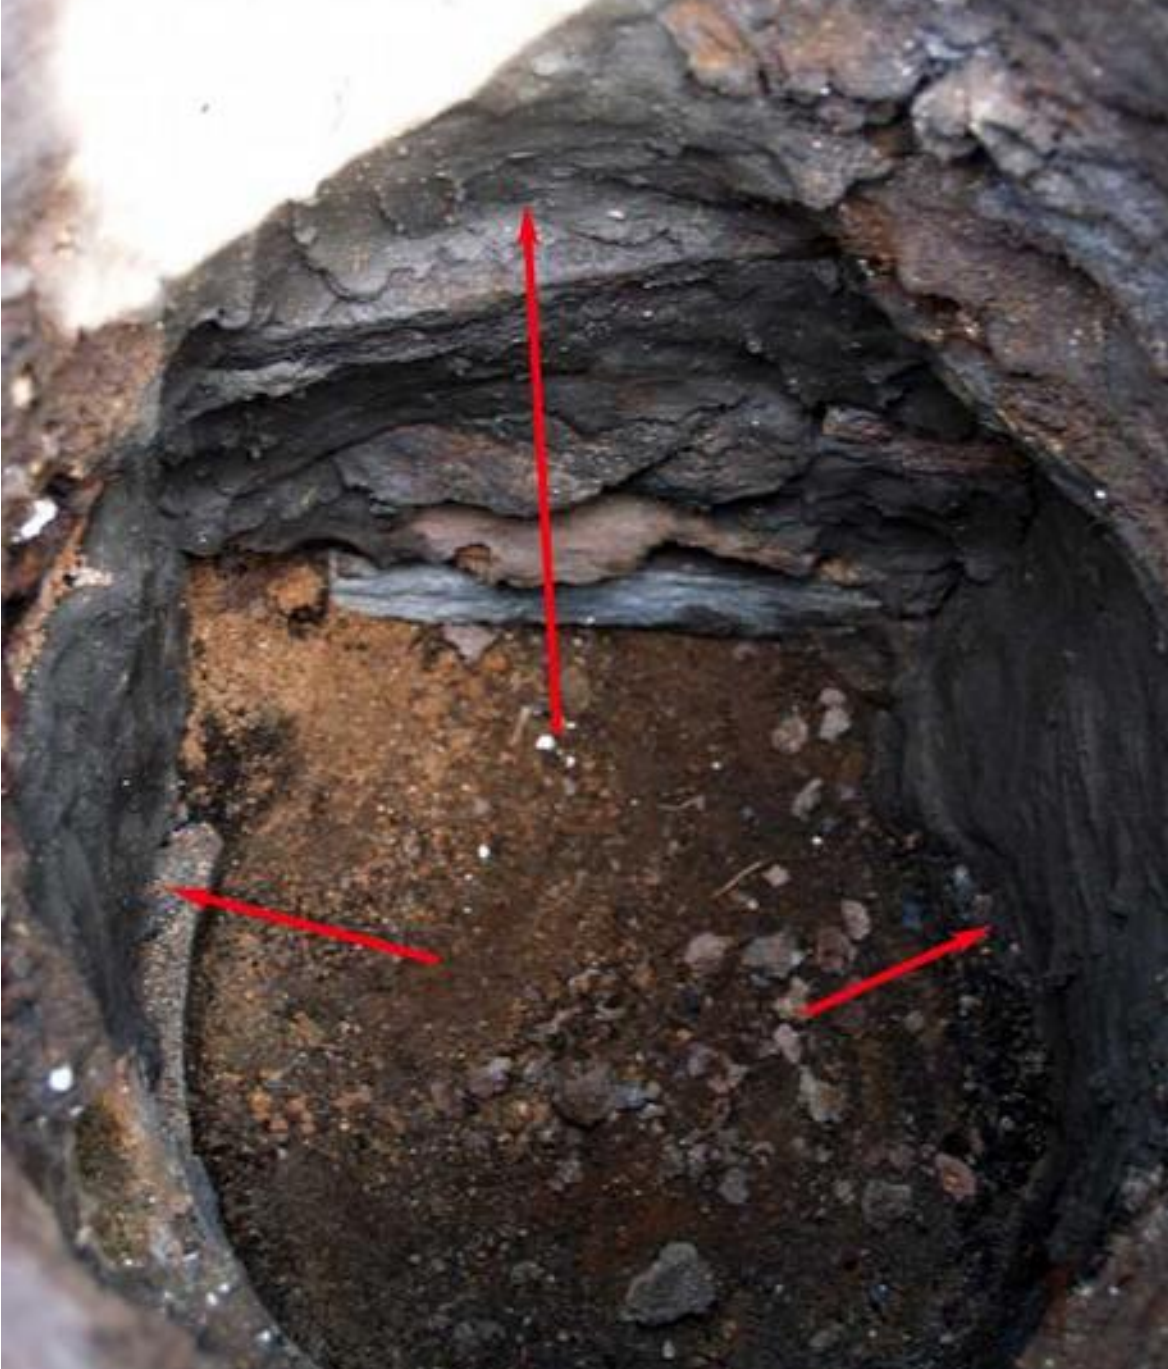
Interior after patching, larger areas indicated. At the top is seen the straight line of the lintel stone, which will support the tuyere tip when that is installed. The edges of the extraction arch stones are seen below the lintel.

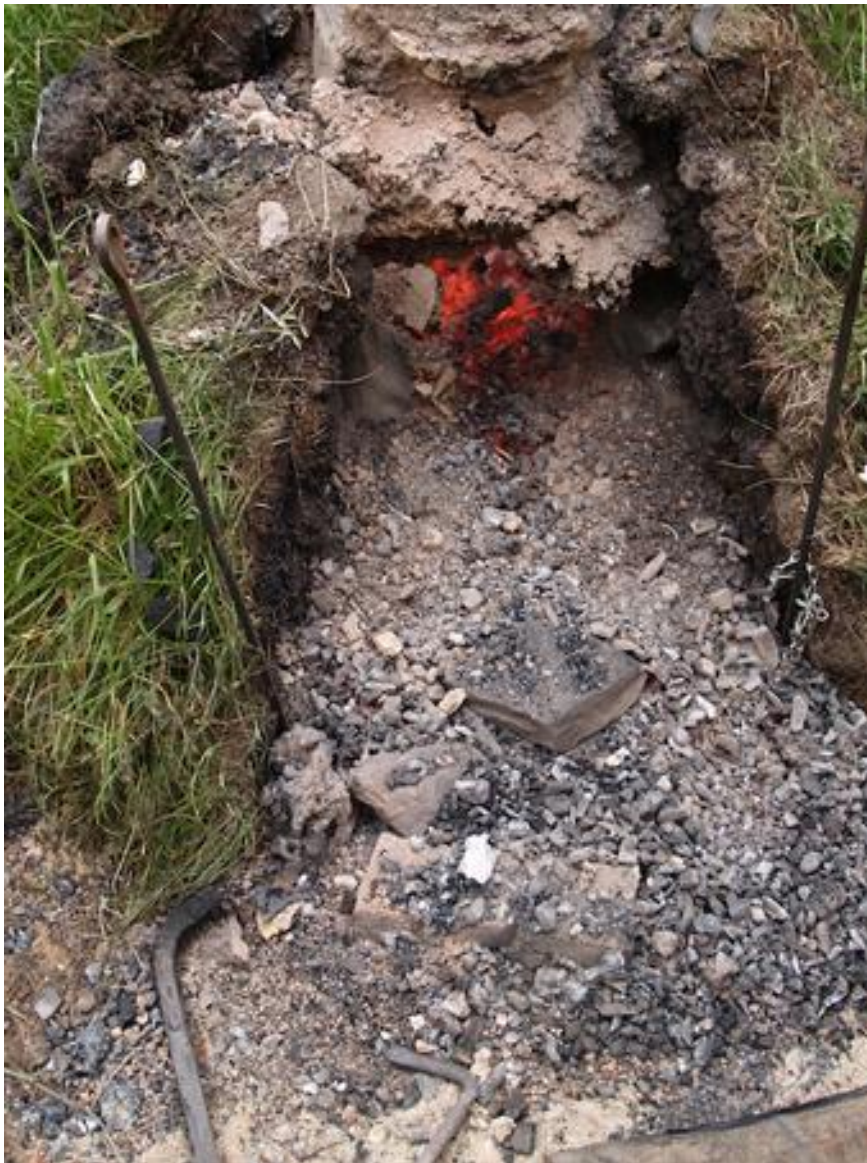
Debris at the front of the furnace, after extraction. Note the mass of fused dirt, the result of the burn through of the front wall above the tuyere.

than was expected. The stones supporting the front of the furnace ended up all being removed. As the strips of sod above the fallen lintel block collapsed, it was obvious there had been a major burn through of the front wall, with fused dirt now attached in a thick band in the area above the tuyere. The entire tuyere and air supply system would pull off, dropping into the fan of hot debris at the front of the furnace.

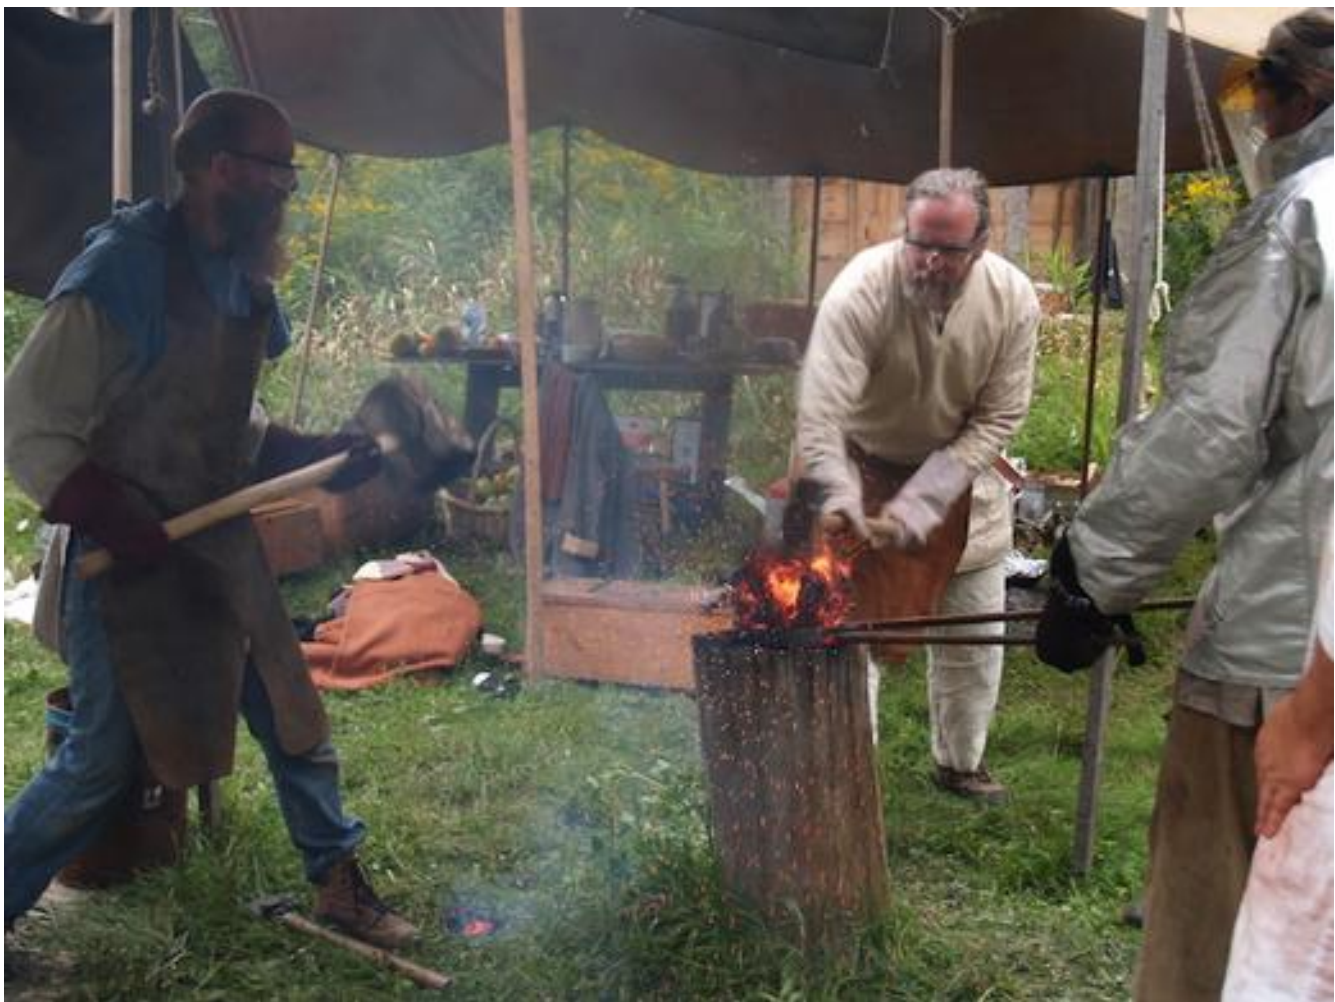
Marcus Burnham with the ‘Troll Hammer’, Richard Schwitzer with a standard sledge, Dave Cox holding. The slag shows as the darker material still encasing the hot metallic bloom core.

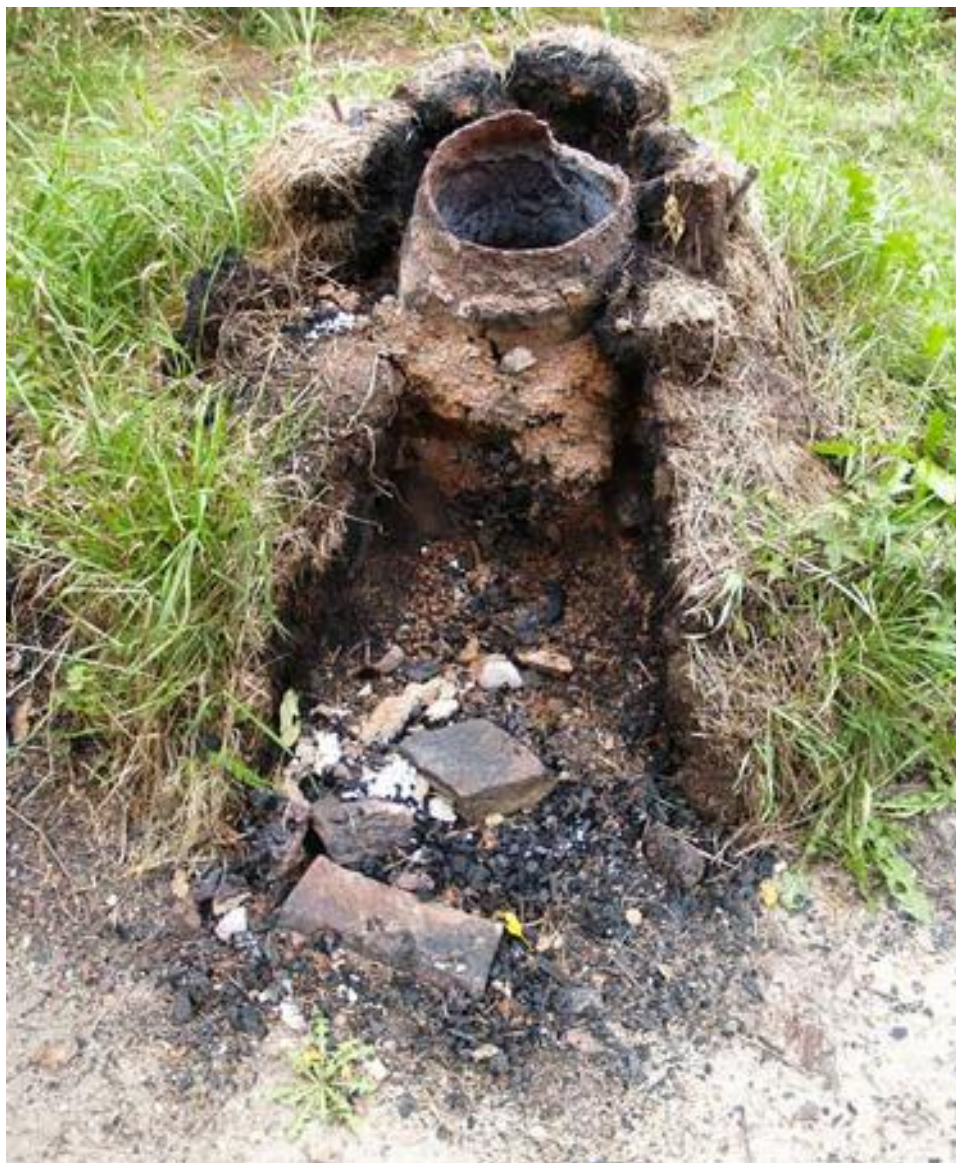
Rain erosion, September 24 - compare with post smelt image seen above (pg 16).

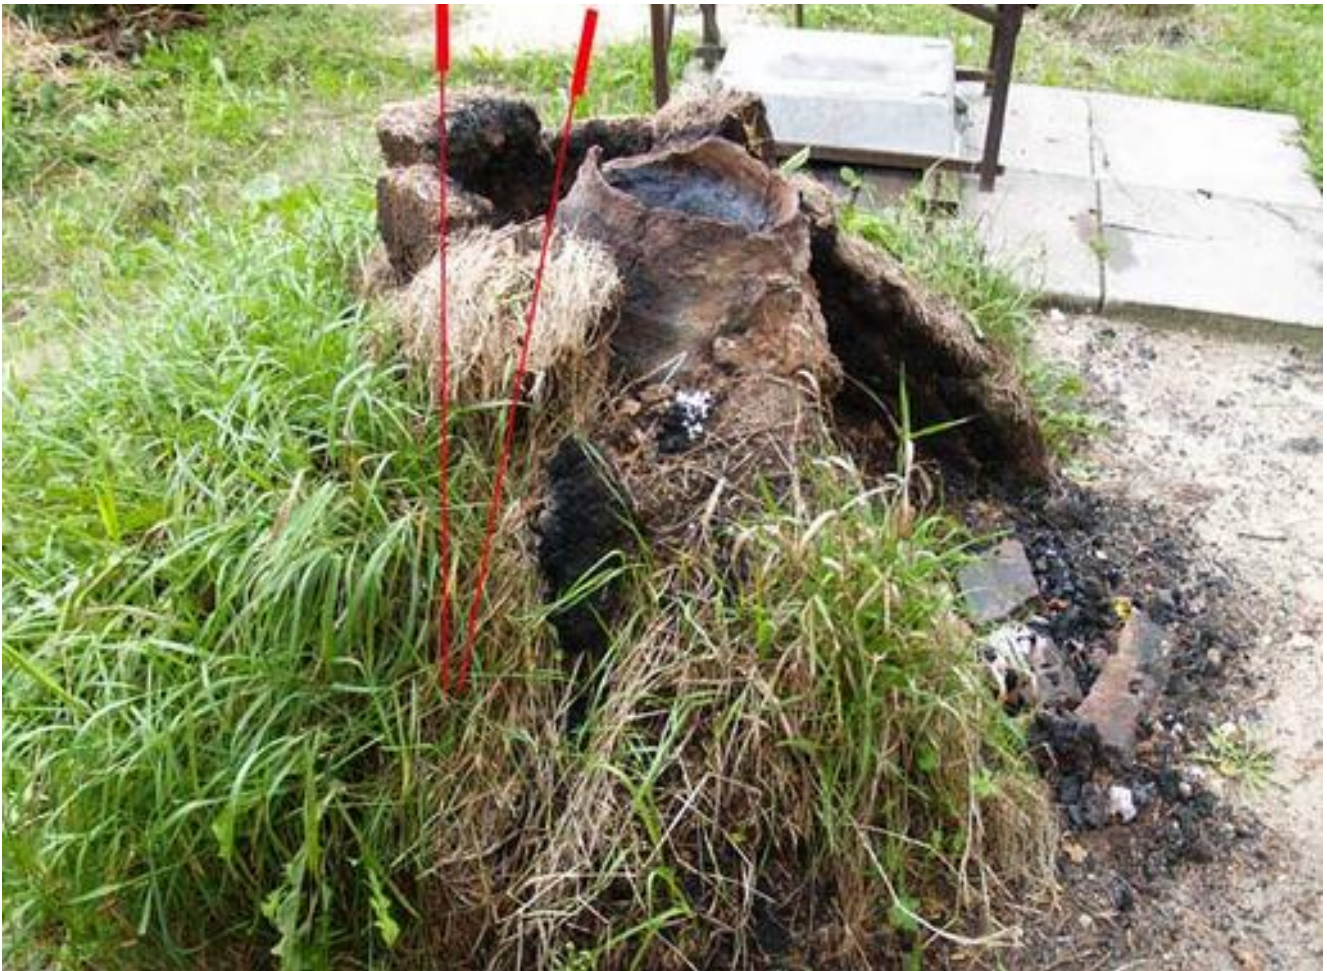
Side view, showing slumping of the furnace towards the extraction side (to right).

Photographs of the furnace have been made several times over the month of September, and will be ongoing over coming months. The image above shows the slumping forward of the remaining clay liner, a total of roughly 17 degrees off the original vertical, over the first 20 days since the last firing. Any attempt to re-use this furnace would most certainly require as a first step clearing away the falling dirt, and restoring the line of the liner to vertical. Given the overall fragile condition of the clay, especially along the mass of fused dirt on the front wall, it is considered unlikely that such a re-adjustment would even prove possible.
